CFM56 BEVEL GEAR SHAFT FORWARD THREAD REPLACEMENT-REPAIR 005 AFI KLM E&M SINGLE REPAIR SOURCE

The MRO Lab
Adaptive Innovations

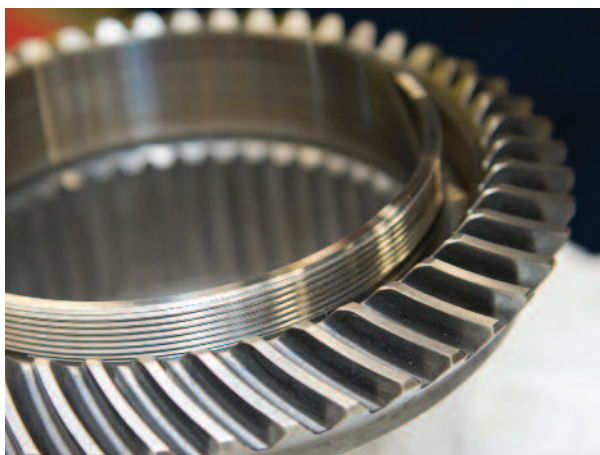
The repair has been approved by GE and introduced into the repair shop manuals as repair EM 72-61-02 R005. It is now available for the most widespread CFM56 engines types: 5A, 5B, 5C and 7B.

- Cut the damaged thread from the gear shaft
- Machine an LMS (Locally Manufactured SpaD) that perfectly fits the gear shaft
- Weld the two pieces using EBW technology
- Machine the thread
- Machine the location holes for the pins
