ON-WING FAN CASE ABRADABLE SEAL REPAIR

MAXIMIZING AIRCRAFT AVAILABILITY WITH ON-WING REPAIR

The MRO Lab
Adaptive Innovations

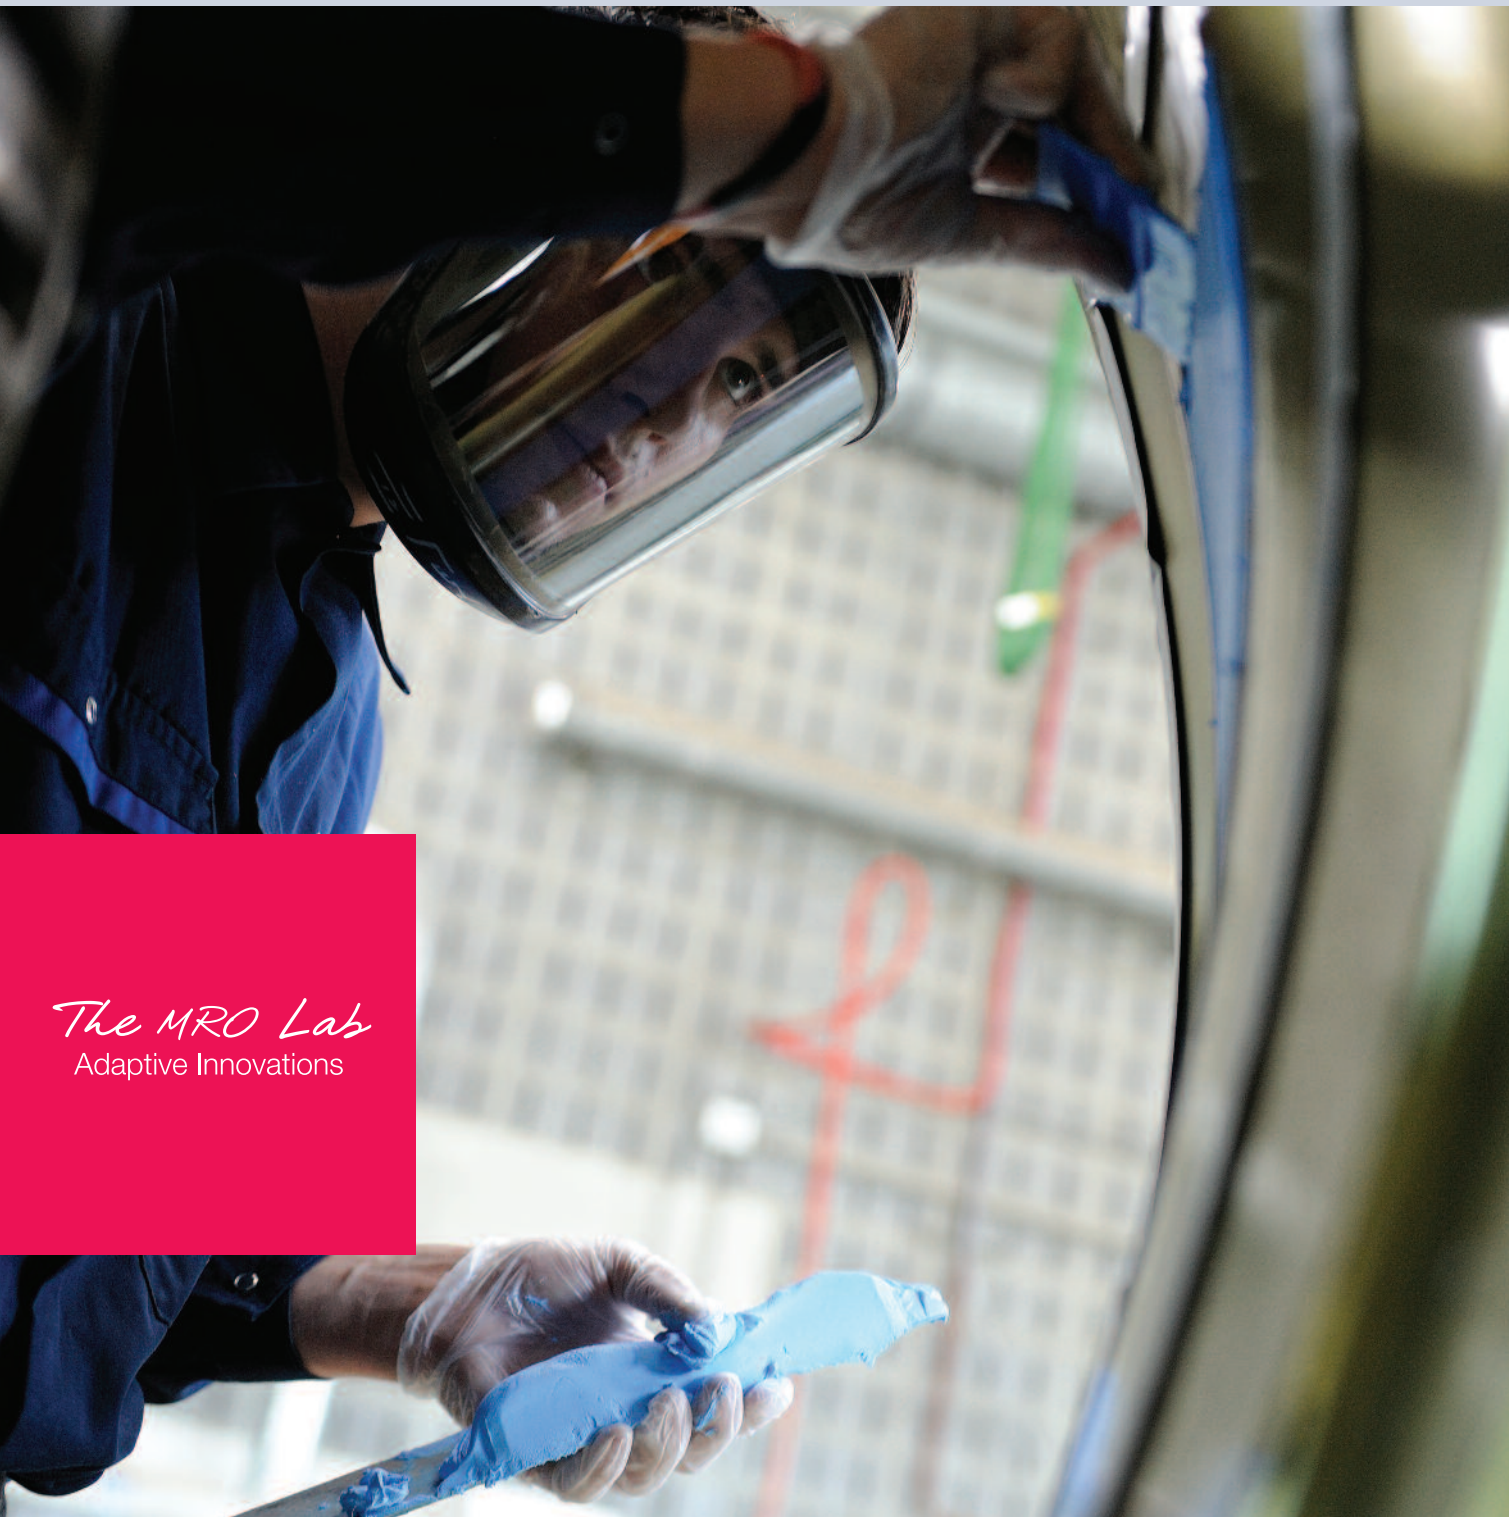
The on-wing abradable repair can be performed on a platform or in a hangar. AFI KLM E&M has developed a specially-designed inflatable tent that surrounds the entire Fan Case area and includes an air conditioning unit.

- Contain and collect the grinding debris and filter the air in the working area. This allows parallel activities on the aircraft and even simultaneous activities on the rear side of the engine.
- Create a temperature & humidity controlled environment during the filler application and curing process.
